# Director's Report

**Southern Clinton  
County Municipal  
Utilities  
Authority**

**Volume 10 Issue 7**

July 18, 2017

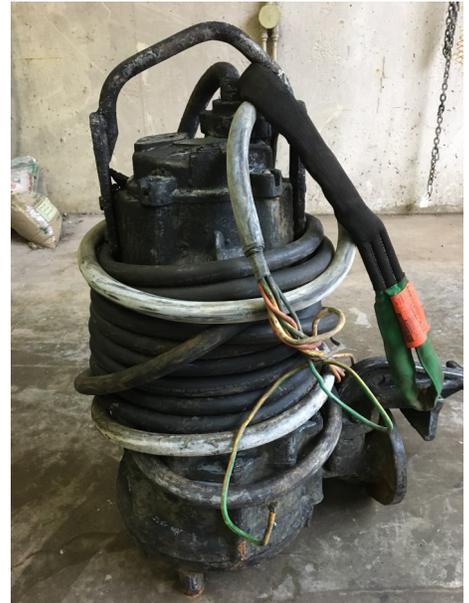
Pump/Motor LS 404

There has been a flurry of pump failures in Watertown; we had three pumps fail within a week. Astonishingly, two of those pumps are located in the same station—LS 404. The pumps have been in service since 2003 and had similar failures within days of each other. This is very rare, but the failures were due to mechanical seal failure which have a life span. We are reviewing trends on seal failures to anticipate a target date to make repairs before the failures occur. This will be difficult in older and previously repaired pumps, but can be vital in original pumps.
