# Director's Report

**Southern Clinton  
County Municipal  
Utilities  
Authority**

Volume 11 Issue 6

June 19, 2018

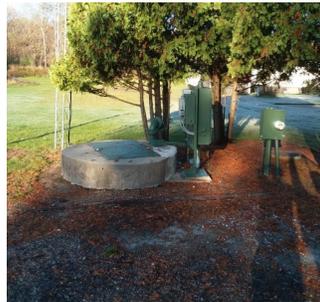
LS 206—Before

The Bath Twp LS 206 rehab, started last year, was a success story for the SCCMUA crew. Our crew did an outstanding job transforming this station at minimal cost. This project was substantially completed at the end of last year with the final touches finished this spring. This project highlights the talent that we have on staff and the ability to find new ways to solve issues cost effectively.

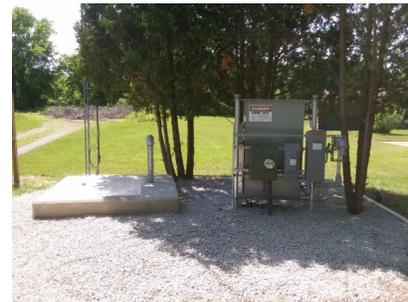
LS 206—After

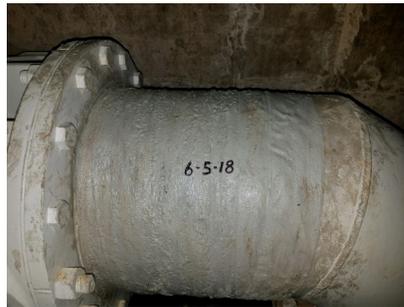
In the metering chamber, flows from the municipalities come in through individual lines as well as what is combined at LS 501 and are metered prior to combining in the wet well. Due to the design, there is an air gap at the top of the pipe before the pipe is reduced into the flow meter. The air gap is exposed most of the time, except during high flow events. This increases corrosion. These pipes, per

Repaired Pipe –City Influent

original design, did not offer any corrosion resistance. The internal atmosphere is conducive to corrosion which has begun to cause failures in the tops of some of the

piping. Pipe patches have been installed to prevent the pipe from leaking and permanent repair and/or replacement options are being looked at, as this will need to be addressed in the future.
