Director's Report

**Southern Clinton
County Municipal
Utilities
Authority**

**Volume 11 Issue 3
1**

March 20, 2018

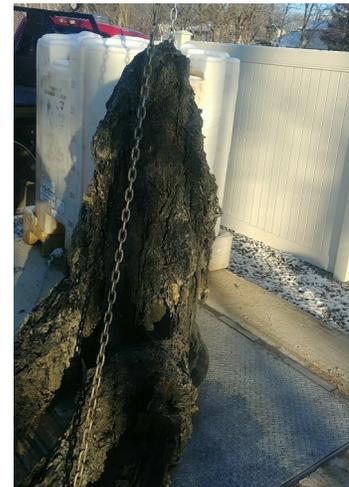
This is a rag ball covering a pump at LS 504. →

Over a significant amount of time of average flows, some of the heavier items have a tendency to settle in pipes, man-holes, and stations. With high flows, these heavy items get washed to the stations, if they are not already there. The flow in the station works like a washing machine and small items become large twisted masses. These large masses are detrimental to pump operations as they can weigh hundreds of pounds. The fine stringy material can also wrap into the impellers and around the drive shafts and potentially damage seals. This is just a by-product of the work we do.
