November 19, 2019

Southern Clinton County Municipal Utilities Authority

Volume 12 Issue 11

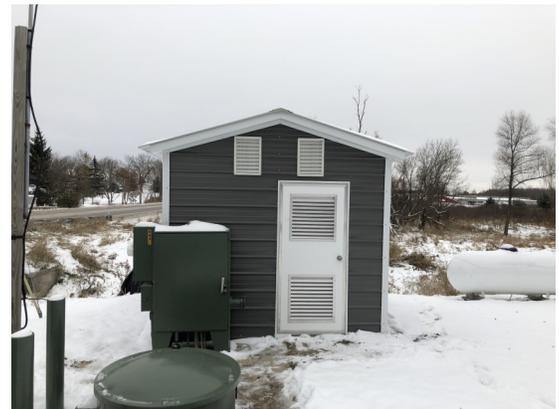
LS 402 Generator Bldg

Station 402 in Watertown Township has under gone many improvements this year. These improvements included a new Fairbanks pump to replace one of the original Allis Chalmers pumps from 1984. The other original pump will be upgraded in the coming years. Also, a standby emergency generator was installed along with a building to house the controls and generator. All of this will help bolster the Watertown system as additional flows come in. This work was all completed by SCCMUA staff which saves dollars and gives full control of the end product.

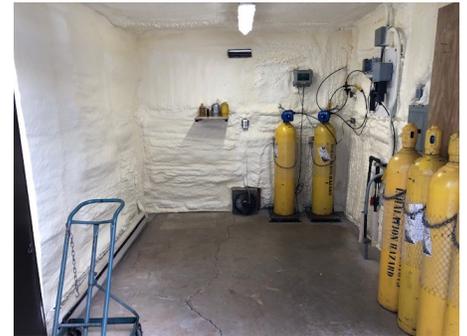
SO₂ building insulation

With the weather starting to get cold, it made us start to think warmth. We had the Sulfur Dioxide (SO₂) building insulated using spray foam. The building is a concrete structure that didn't retain much heat from the little baseboard heater that we had; what a difference it made. This will lower energy costs by half or more for that building as it was uninsulated and has to remain above freezing.
