Southern Clinton County Municipal Utilities Authority

Volume 13 Issue 8

Maintenance—Keeping Things Humming

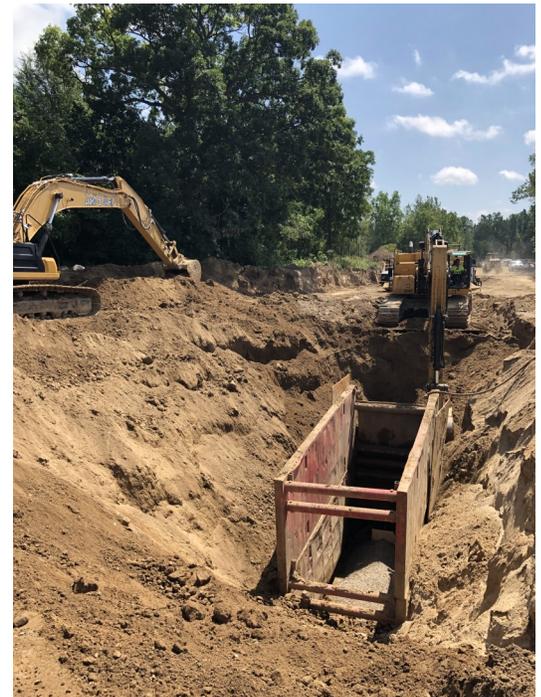
While this picture doesn't do the "hole" justice, this is on the 102 interceptor north of Solon Rd.

102 Interceptor: The work to install the new pipe for the southern portions of DeWitt Twp has continued with work completed south of Clark Rd. nearing Solon Rd. The project should have substantial completion by month end.
